**Flood Control Project Maintenance
Levee Inspections**

Fall 2009 Levee Maintenance Deficiency Summary Report

Reclamation District No. 0900 West Sacramento

Levee Inspection Report By Mile - Fall 2009

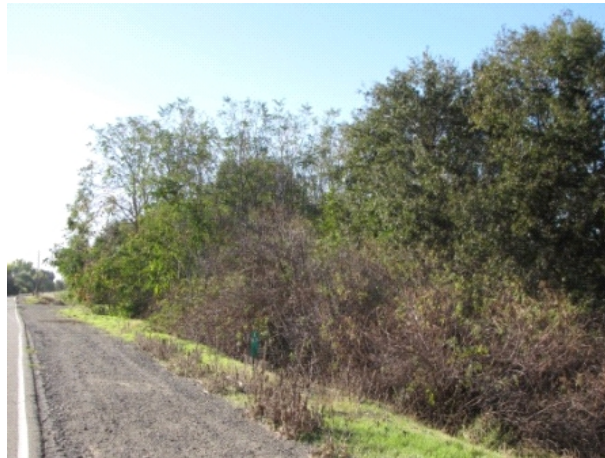
Levee Mile Report Line	5
Start Levee Mile	2.21
End Levee Mile	2.24
Location	Land Side
Category	Earthen Levee
Item	Vegetation

5	2.21	2.24	Earthen Levee	Vegetation	LS	M	Elderberries are blocking visibility and flood fight capability.	38.556286 ° -121.516583 °	38.555833 ° -121.516382 °	966 Y
6	2.24	2.28	Earthen Levee	Trim / Thin Trees	LS	M	Trim trees to at least five feet above ground level.	38.555917 ° -121.516416 °	38.555337 ° -121.516166 °	6
7	2.36	2.40	Earthen Levee	Trim / Thin Trees	WS	C	Trim trees to at least five feet above ground level.	38.554125 ° -121.515687 °	38.553523 ° -121.515487 °	8
8	2.39	2.39	Earthen Levee	Trim / Thin Trees	WS	M	Thin trees to allow visibility of the ground and room to flood fight.	38.553751 ° -121.515497 °	38.553751 ° -121.515497 °	967
9	2.45	2.45	Earthen Levee	Trim / Thin Trees	WS	C	Trim trees to at least five feet above ground level.	38.552853 ° -121.515270 °	38.552853 ° -121.515270 °	9
10	2.53	2.57	Earthen Levee	Trim / Thin Trees	WS	C	Trim trees to at least five feet above ground level.	38.551695 ° -121.514982 °	38.551210 ° -121.514863 °	10

View of elderberry bushes with trees in the background blocking visibility and access along the landward slope looking downstream.

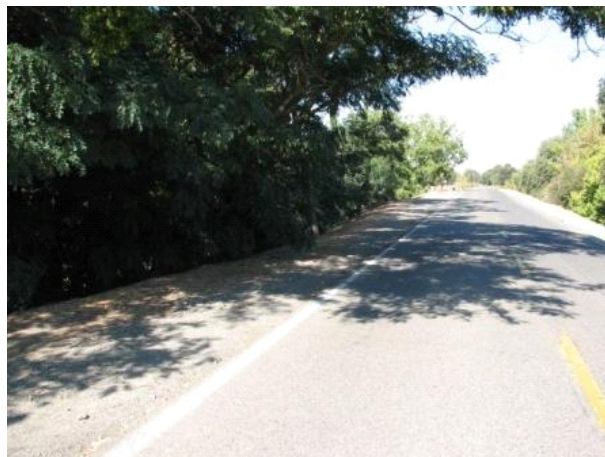
Levee Mile Report Line	11
Start Levee Mile	2.56
End Levee Mile	2.64
Location	Land Side
Category	Earthen Levee
Item	Trim / Thin Trees

11	2.56	2.64	Earthen Levee	Trim / Thin Trees	LS	M	Trim trees to at least five feet above ground level.	38.551278 ° -121.514877 °	38.550235 ° -121.514577 °	11 Y
12	2.62	2.62	Earthen Levee	Trim / Thin Trees	WS	C	Trim trees to at least five feet above ground level.	38.550428 ° -121.514640 °	38.550428 ° -121.514640 °	12
13	2.78	2.78	Earthen Levee	Trim / Thin Trees	WS	M	Trim and thin trees to allow visibility of the ground and room to flood fight.	38.548340 ° -121.513580 °	38.548340 ° -121.513580 °	962
14	3.19	3.19	Earthen Levee	Vegetation	LS	M	Remove the wild growth other than native grasses from the levee slopes.	38.542656 ° -121.513070 °	38.542656 ° -121.513070 °	968
15	3.38	3.55	Earthen Levee	Vegetation	LS	M	Remove the wild growth other than native grasses from the levee slopes. Inspector Comments: Horsetail above the lower berm.	38.540175 ° -121.514859 °	38.538588 ° -121.516987 °	969 Y
16	3.43	3.69	Earthen Levee	Trim / Thin Trees	WS	C	Trim trees to at least five feet above ground level.	38.539683 ° -121.515407 °	38.537303 ° -121.519118 °	14

Trim trees to 5' from surface of levee on landside slope from LM 2.56 to LM 2.64

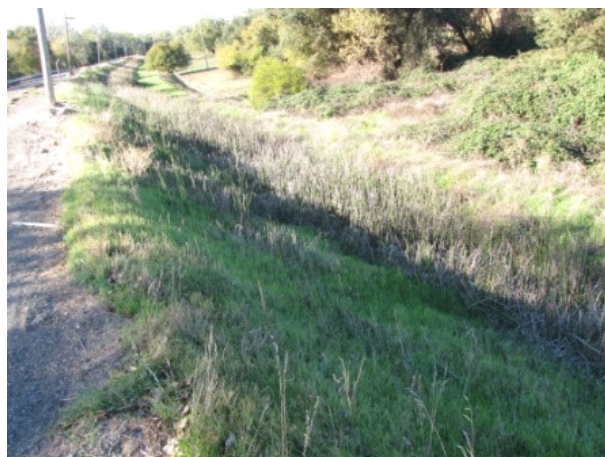
Levee Mile Report Line	15
Start Levee Mile	3.38
End Levee Mile	3.55
Location	Land Side
Category	Earthen Levee
Item	Vegetation

View of excessive vegetation blocking visibility and access along the landward slope looking downstream.

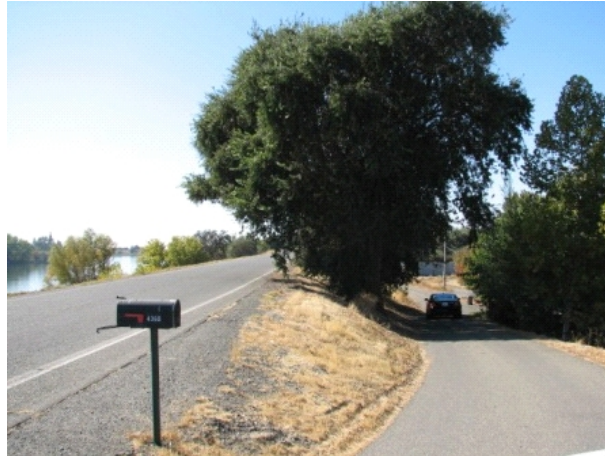
Levee Mile Report Line	55
Start Levee Mile	6.25
End Levee Mile	6.28
Location	Land Side
Category	Earthen Levee
Item	Trim / Thin Trees
Trim trees to 5 feet from levee surface LM 6.25-6.28	
dpesaven_20091028_222.jpg

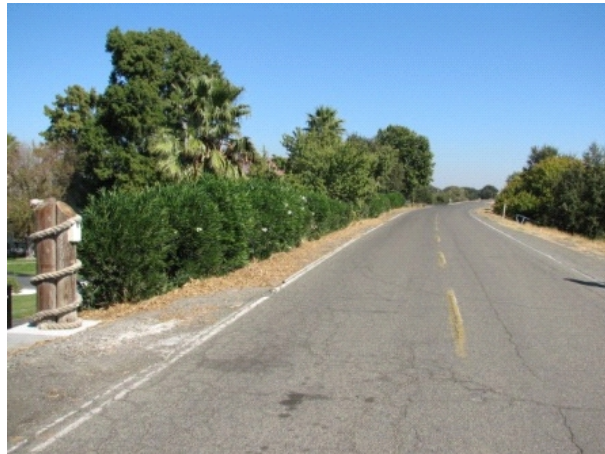
Levee Mile Report Line	58
Start Levee Mile	6.56
End Levee Mile	6.63
Location	Land Side
Category	Earthen Levee
Item	Encroachments
Landscape encroachment at LM 6.56 to LM 6.63	
dpesaven_20091028_223.jpg

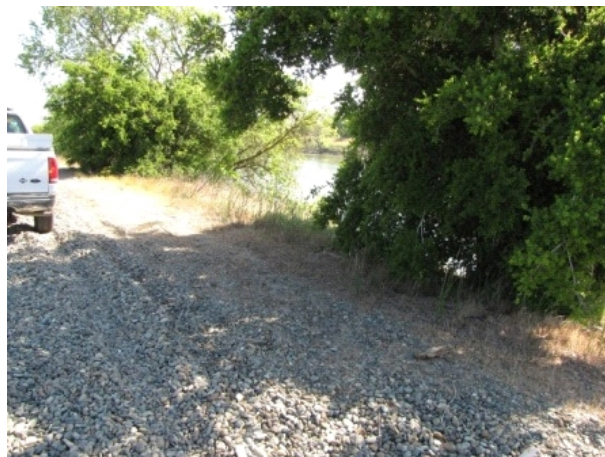
Levee Mile Report Line	71
Start Levee Mile	7.44
End Levee Mile	7.44
Location	Water Side
Category	Earthen Levee
Item	Trim / Thin Trees
Trim trees to allow for visibility and ability to flood fight at LM 7.44.	
dpesaven_20091028_224.jpg

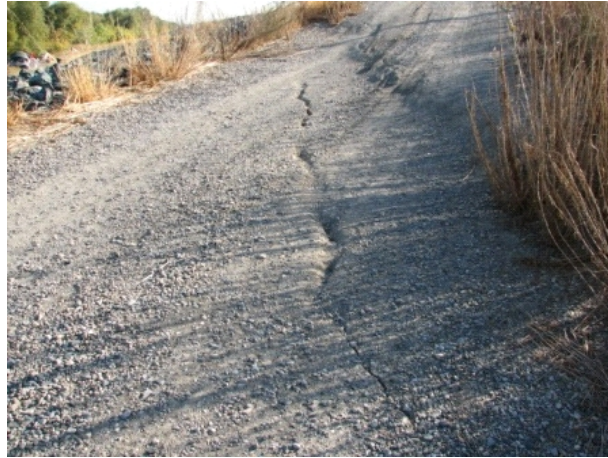
Levee Mile Report Line	1
Start Levee Mile	0.95
End Levee Mile	0.95
Location	Water Side
Category	Earthen Levee
Item	Cracking

Waterway							Bank	Unit Miles	Inspection Start/End	Inspector	
Unit No. 02 Yolo Bypass							Left	5.73	10/29/2009 10/29/2009	David Pesavento	
LMR No.	Levee Mile		Category	Item	Location	Rating	Action/Comment	GPS Latitude/Longitude		Issue No.	
	Start	End						Start	End	Photo	
1	0.95	0.95	Earthen Levee	Cracking	WS	M	Monitor and have inspected by geotechnical engineer. Inspector Comments: Cracks located on waterside on ramp toward under I-80, some slumping	38.574250 ° -121.581517 °	38.574250 ° -121.581517 °	10 Y	
2	1.10	2.90	Earthen Levee	Vegetation	WS	A	Remove the wild growth other than native grasses from the levee slopes. Inspector Comments: Unable to access the levee due to Corps construction.	38.572240 ° -121.582353 °	38.546146 ° -121.582131 °	29	
3	3.10	3.10	Earthen Levee	Crown Surface / Depressions / Rutting	CR	C	Add appropriate gravel or road base. Grade and compact.	38.543313 ° -121.582132 °	38.543313 ° -121.582132 °	25

Crack located on ramp on waterside of levee at LM 0.95.

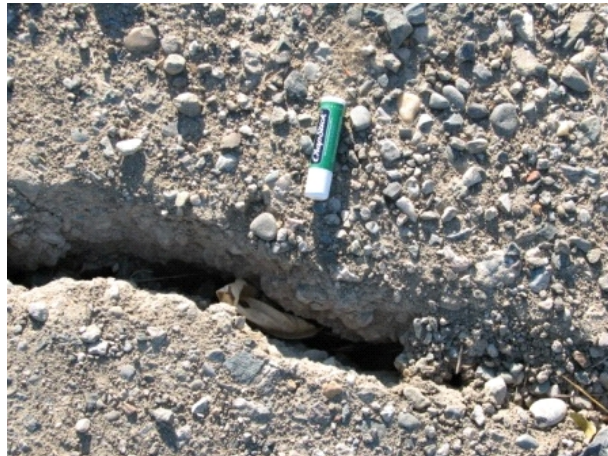
Levee Mile Report Line	1
Start Levee Mile	0.95
End Levee Mile	0.95
Location	Water Side
Category	Earthen Levee
Item	Cracking

Closer view of crack at LM 0.95.

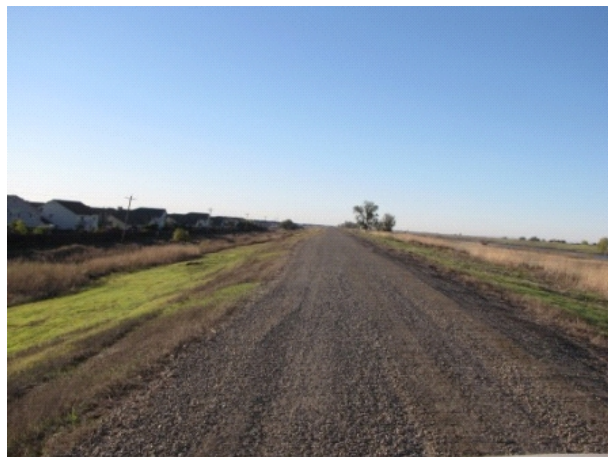
Levee Mile Report Line	4
Start Levee Mile	3.29
End Levee Mile	5.70
Location	Land Side
Category	Earthen Levee
Item	Vegetation

4	3.29	5.70	Earthen Levee	Vegetation	LS	A	Remove the wild growth other than native grasses from the levee slopes.	38.540635 ° -121.582214 °	38.505774 ° -121.582077 °	30 Y	
5	3.29	5.70	Earthen Levee	Vegetation	WS	A	Remove the wild growth other than native grasses from the levee slopes.	38.540634 ° -121.582212 °	38.505773 ° -121.582077 °	31	
6	4.97	4.97	Earthen Levee	Vegetation	CR	A	Remove the wild growth other than native grasses from the levee slopes. Inspector Comments: Ongoing construction at the pump station, permit 18116.	38.516359 ° -121.582215 °	38.516359 ° -121.582215 °	32	
7	5.01	5.01	Earthen Levee	Slope Stability	LS	C	Repair slope instability.	38.515663 ° -121.582268 °	38.515663 ° -121.582268 °	28

View of an example of the vegetation maintenance done along this unit looking downstream.
